AFWL-TR-76-300

# DEVELOPMENT OF GAGE CANISTER RECOVERY TECHNIQUE

**Final Report**

AIR FORCE WEAPONS LABORATORY Air Force Systems Command Kirtland Air Force Base, NM 87117 This final report was prepared by the Air Force Weapons Laboratory, Kirtland Air Force Base, New Mexico under Project ILIR-75-09. Mr. David J. Fogelson (DED) was the Laboratory Project Officer-in-Charge.

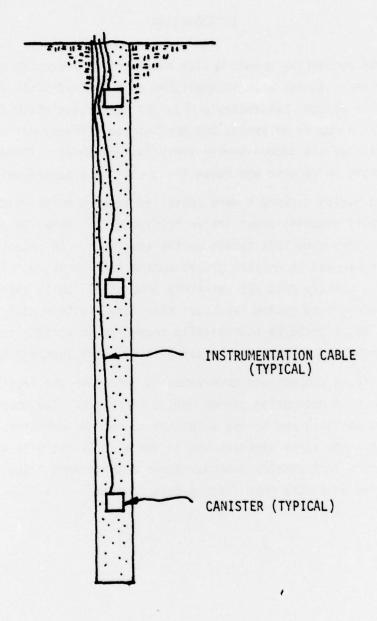
Figure 1. Typical Canister Installation

The ground motion canisters were installed in bore holes which were backfilled with a soil matching grout (refer to figure 1). Normally after a test event, the canisters were left intact on the test site. In recent years, the price of the gages used to measure ground motion has increased. For example, accelerometers presently cost approximately \$450 each. Up to three gages may be installed in each ground motion canister; therefore, it is readily apparent that if some of the gages could be economically recovered in working condition, a considerable amount of money could be saved in fielding succeeding tests.

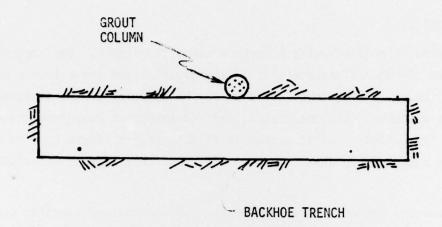
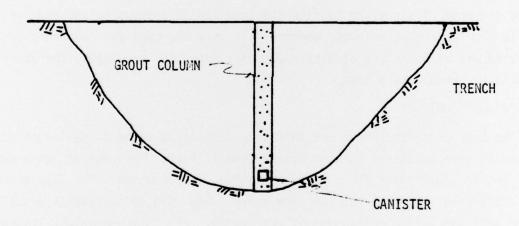
Figure 2. Backhoe Recovery

The method of recovery with a backhoe was quite simple. The backhoe was positioned to dig down along one side of the grout column and a trench was dug next to the column to a depth slightly below the position of the canister. Field crew members descended into the trench, chipped the grout away from the canister, and removed the canister. This method is illustrated in figure 2. The method was employed successfully on a number of different test beds at the HARDPAN I test site.

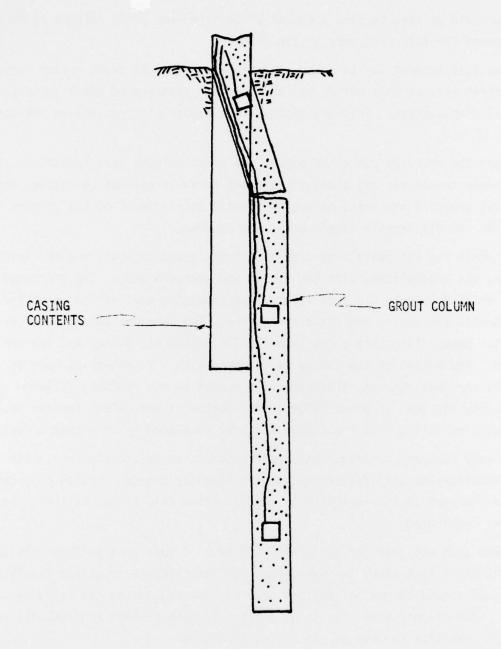
Figure 4. Overcoring Displaced Columns

Three grout columns were selected for recovery at three different distances from the explosive to determine the amount of displacement that could be tolerated in this type of recovery. The first column to be overcored was one of intermediate distance from the explosive. A small mud pit was dug with a backhoe and the drill rig positioned over the grout column. The casing was inserted to a depth of 15 feet with normal waterflow through it. An additional three feet of casing were forced dry to allow the grout column to adhere to the casing. When the casing and contents were removed from the hole, it was apparent that the column was displaced by the explosion. Approximately eight feet of grout were recovered and only the canister nearest to the test bed surface was in the contents. Refer to figure 4 for a pictorial description of the displaced grout column.
